DEPARTMENT OF THE AIR FORCE
OFFICE OF SPECIAL INVESTIGATIONS DISTRICT 51
APO SAN FRANCISCO 96346

SAPPER ATTACK
U-TAPAO AIRFIELD, THAILAND
10 JANUARY 1972

This report is provided as a compilation of information concerning the January attack on U-Tapao Airfield. Investigation concerning identity and affiliation of the intruders is being conducted by Thai authorities. Information resulting from the Thai investigation will be disseminated as received.

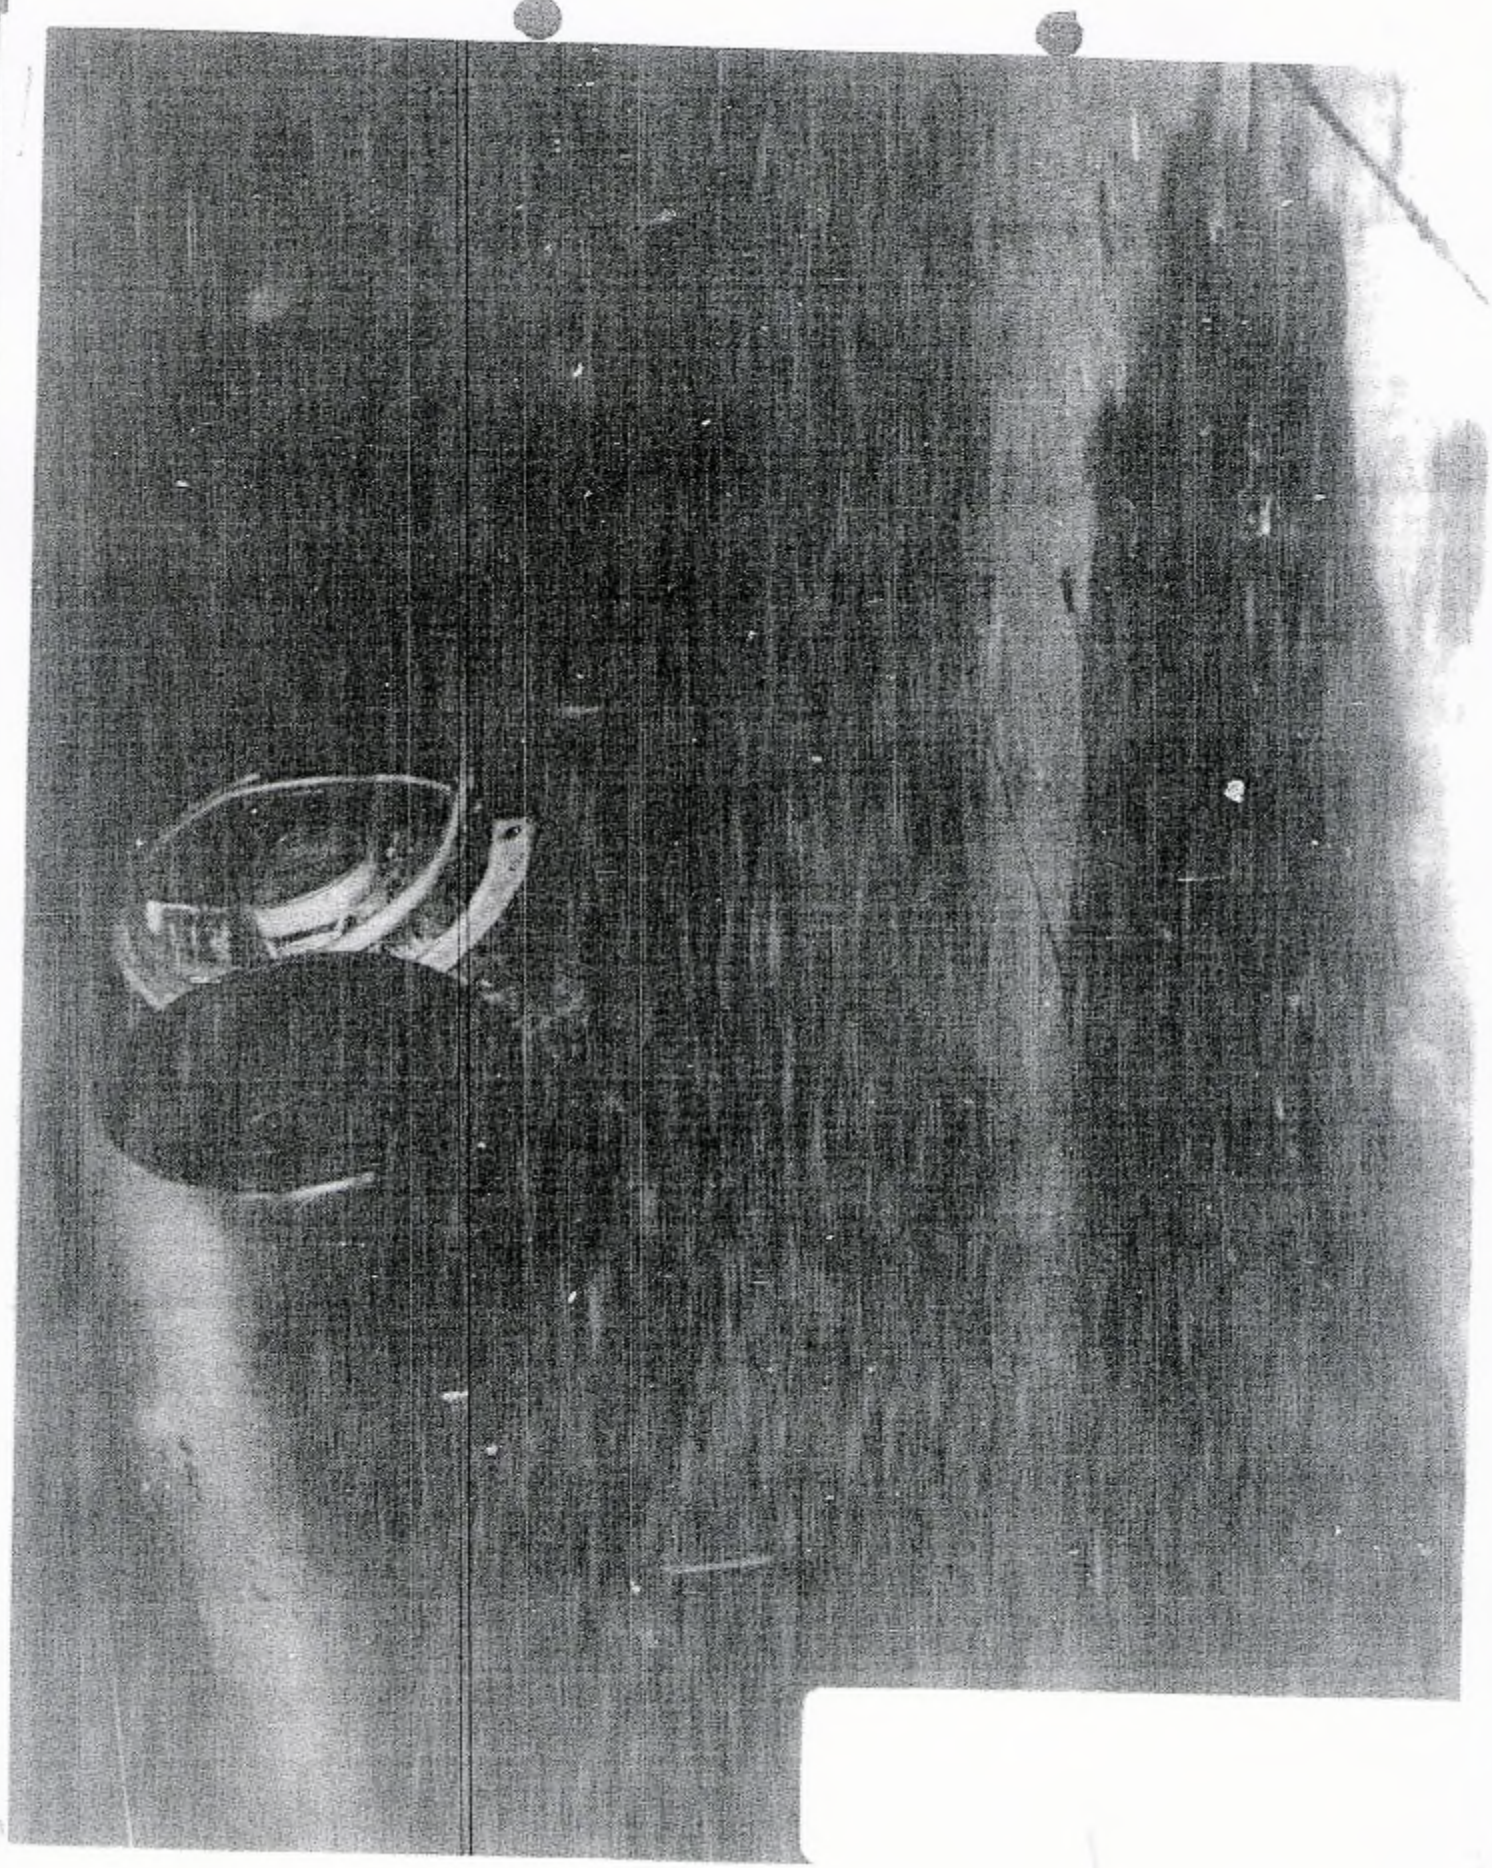
ATTACHMENT 2

SUMMARY: After reaching Mike Row, the penetrators placed one satchel charge in the number seven engine of B-52 #6662 parked in the Mike 1 revetment. This device caused the first explosion (see Attachments 3 and 4). The two intruders then ran across the front of Mike 2. One man ran directly to the rear of the aircraft while the other attempted to throw a satchel charge into the number five or six engine. This charge fell to the ground and exploded. This individual then also ran to the rear of the aircraft and both ran along the revetment wall between Mike 2 and 3 and headed toward the aircraft parked in Mike 3. One satchel charge was thrown at engines seven and eight, but also fell to the ground and exploded, almost in the same position as at Mike 2. Two additional charges were placed in the area which did not explode. One was found inside the air intake engine number four of the aircraft parked in Mike 3 and the other was lying on a concrete revetment shelf behind that aircraft. Both of these charges were found by Explosive Ordnance Disposal (EOD) personnel and were subsequently disarmed.

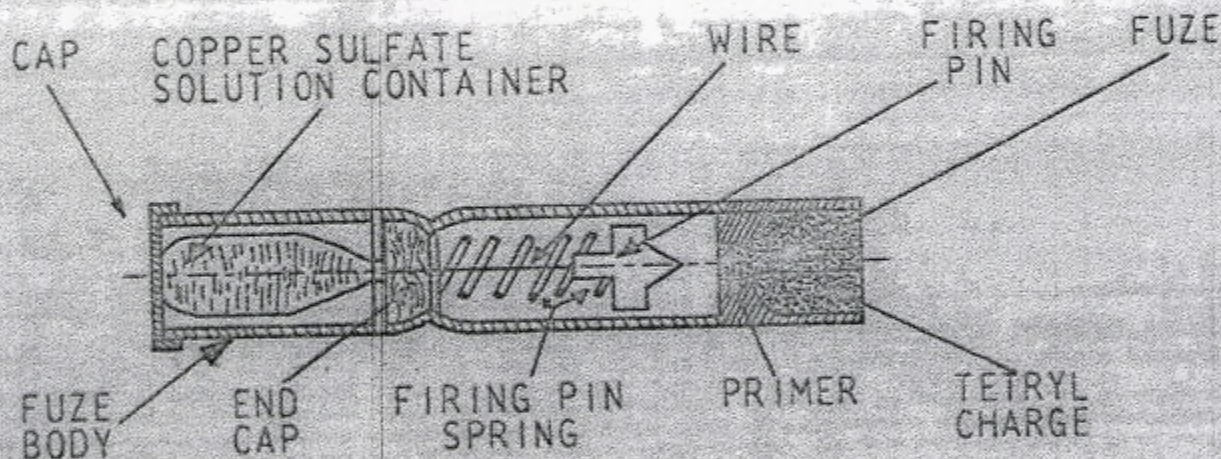
CHEMICAL FIRING DEVICE

The recovered pencil chemical fuzes (See Attachment 6 and 7) appeared identical to those used during the January 1970 Ubon attack. The fuze containers were all a dark maroon plastic with a screw top. The containers all had either two or three painted dots near the base. These dots are raised and appear to be used for determining the time of delay for the fuze inside. In the case of a container with two dots, the number two is impressed into the detonator portion of the fuze. Those with three dots have the number three on the fuze. A laboratory analysis completed on a similar type fuze following the discovery of a 20 April 1969 cache near Ubon, disclosed the explosive in the fuze to be composed of 85% Pentaerythrite Tetranitrate (PETN) and 10.7% Dibutyltinlaid, a plasticizer. The other 4.3% of the material was not given. This compound was determined to be roughly equivalent to Composition 4 (1.3 TNT) explosive, undoubtedly a factory-produced substance. The principal of the chemical fuze is illustrated in Attachment 16. The fuzes used at UTAF were also booby-trapped. The wire

This firing device may be employed by the VC for sabotage purposes. It is attached to mines and demolition charges. Its delay is between 20 and 38 minutes.

FUNCTIONING. The copper sulfate tube is broken and the solution reacts on the metal wire securing the firing pin. The wire is weakened and breaks, allowing the spring driven firing pin to strike the primer, resulting in detonation of the charge.

DISARMING. Once the firing device has been initiated, there is no way to safe the device. In an extreme emergency, unscrew the firing device and place it away from the charge. Evacuate the area and wait at least one hour before returning to examine the device.

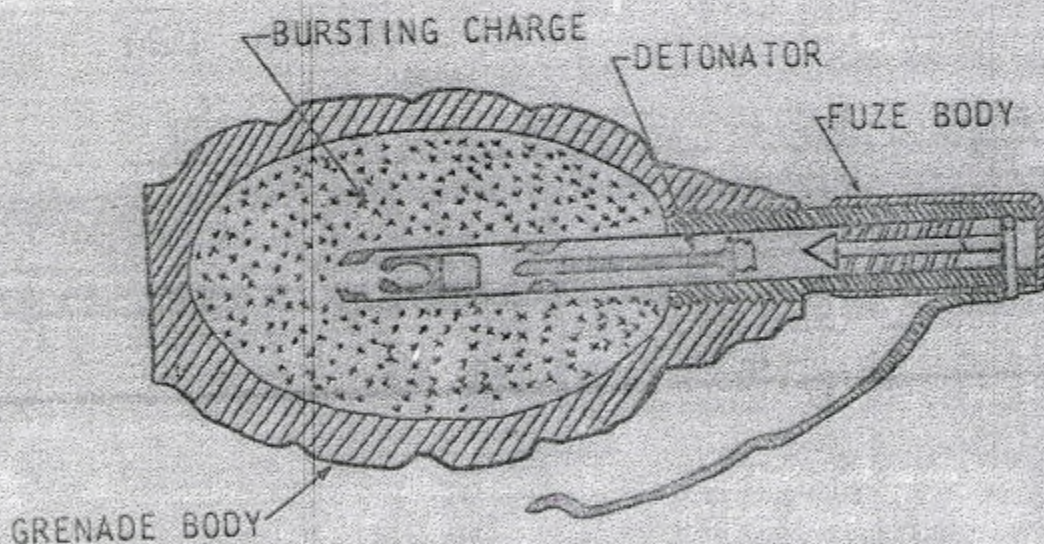
The hand grenades recovered were apparently either a Soviet or CHICOM version of the F-1 fragmentation grenade. Characteristics of this grenade are shown in Attachment 17. The grenades bore no markings which would indicate the country of origin.

SOVIET DEFENSIVE HAND GRENADE TYPE F-1

The F-1 type hand grenade is similar in appearance and operations to those of the US MK.2 grenade. Its case is of serrated cast iron and painted olive drab.
