DEPARTMENT OF THE AIR FORCE
HEADQUARTERS 8th COMBAT SUPPORT GROUP (PACAF)
APO SAN FRANCISCO 96304

SUBJECT: Combat Operations After Actions Report (RCS: PAF-Y1) (U)

1. (U) NAME OR IDENTITY AND/OR TYPE OF OPERATION: Sapper attack against Ubon Royal Thai Air Force Base.

3. (U) LOCATION: Ubon Royal Thai Air Force Base, Ubon Province, Thailand.

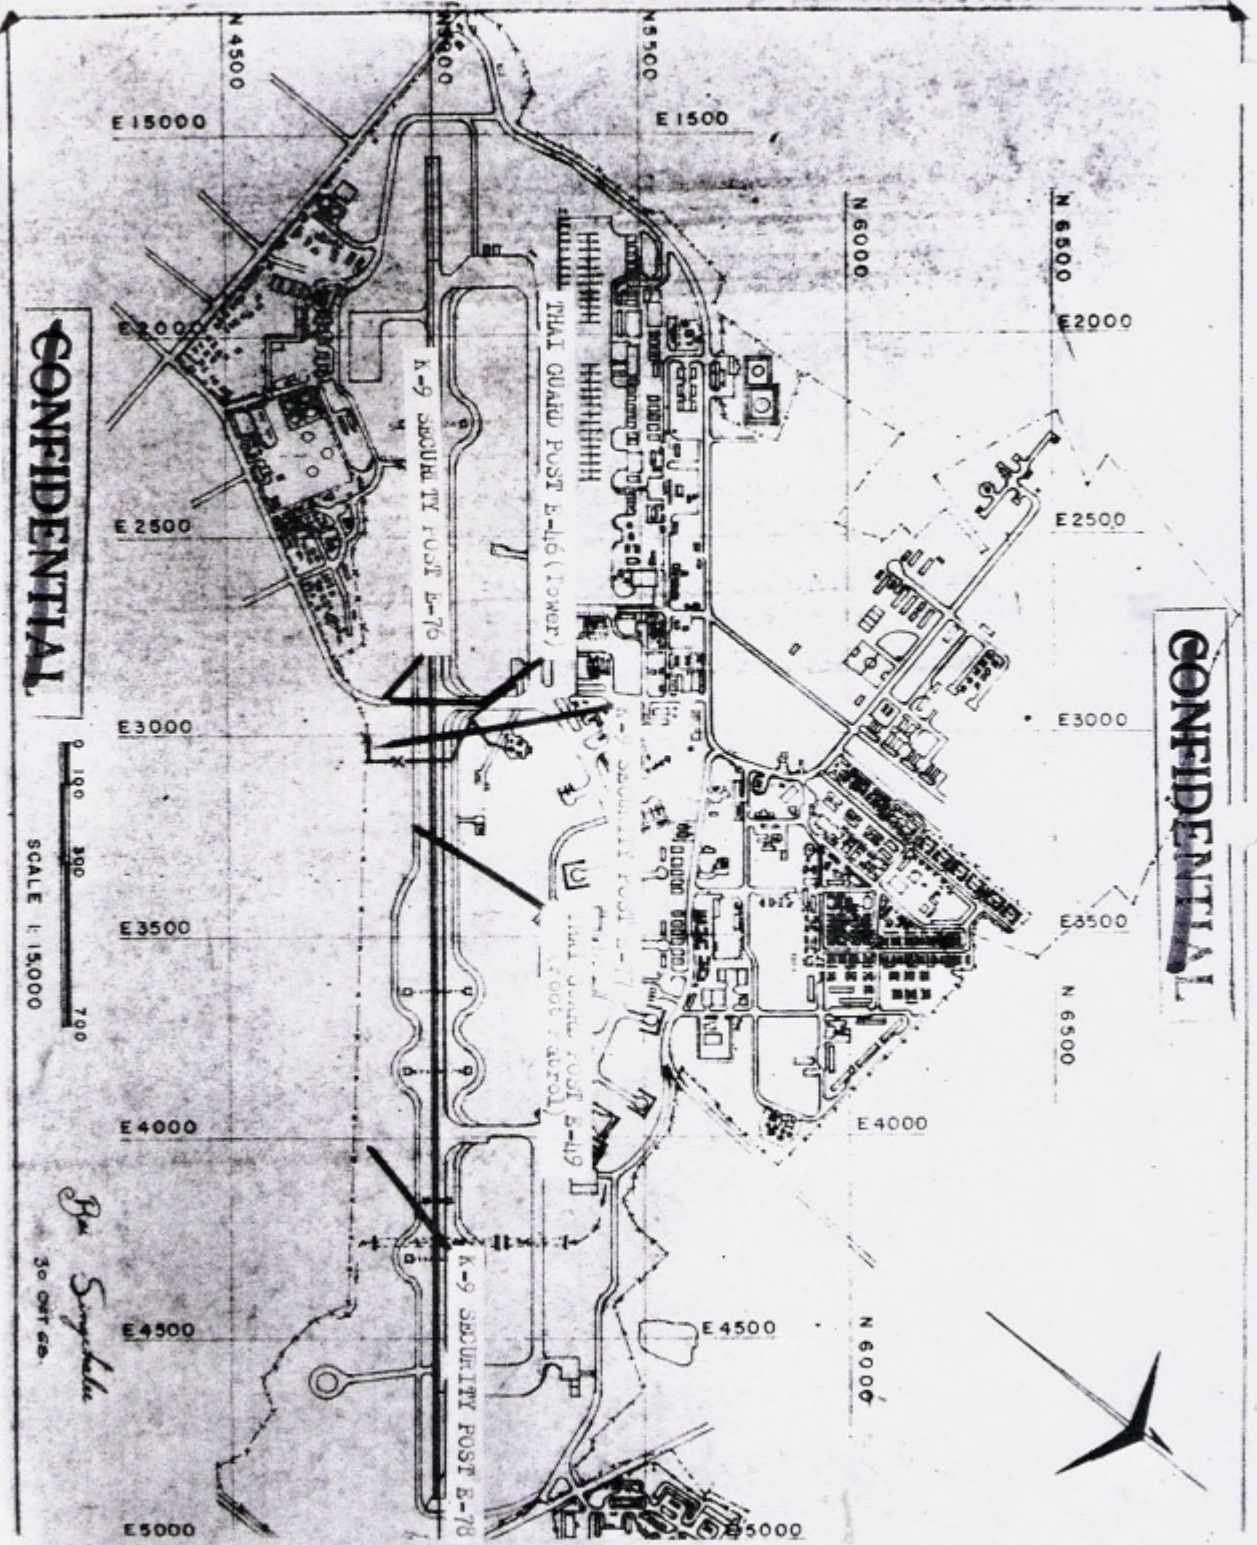
ATCH 3

- (1) Position behind concrete abutment where sentry first received fire.
- (2) Direction of fire on sentry.

- (3) Approximate vicinity of perimeter where infiltrators departed thru fence.

- (4) Path through grass where infiltrators exited thru interior perimeter, also location where Provincial Police discovered items of clothing.

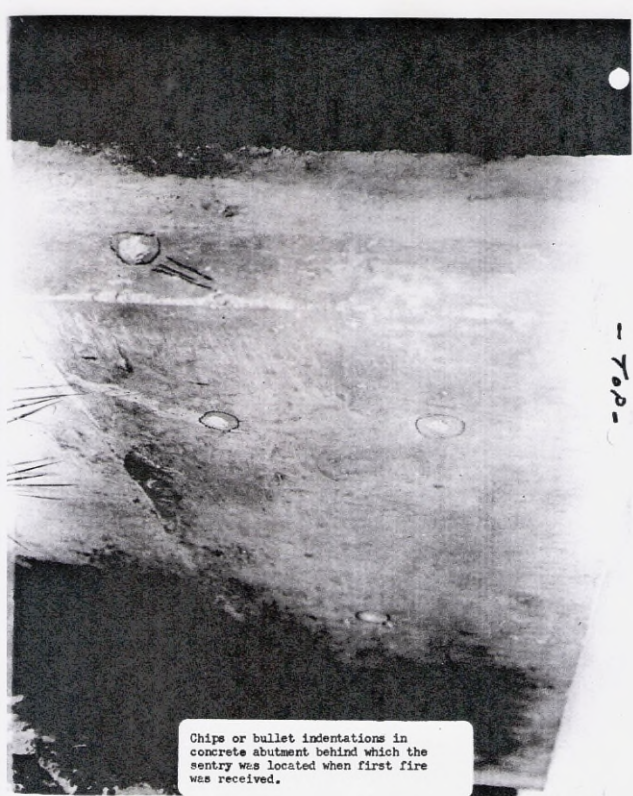
ATCH 4

Chips or bullet indentations in concrete abutment behind which the sentry was located when first fire was received.

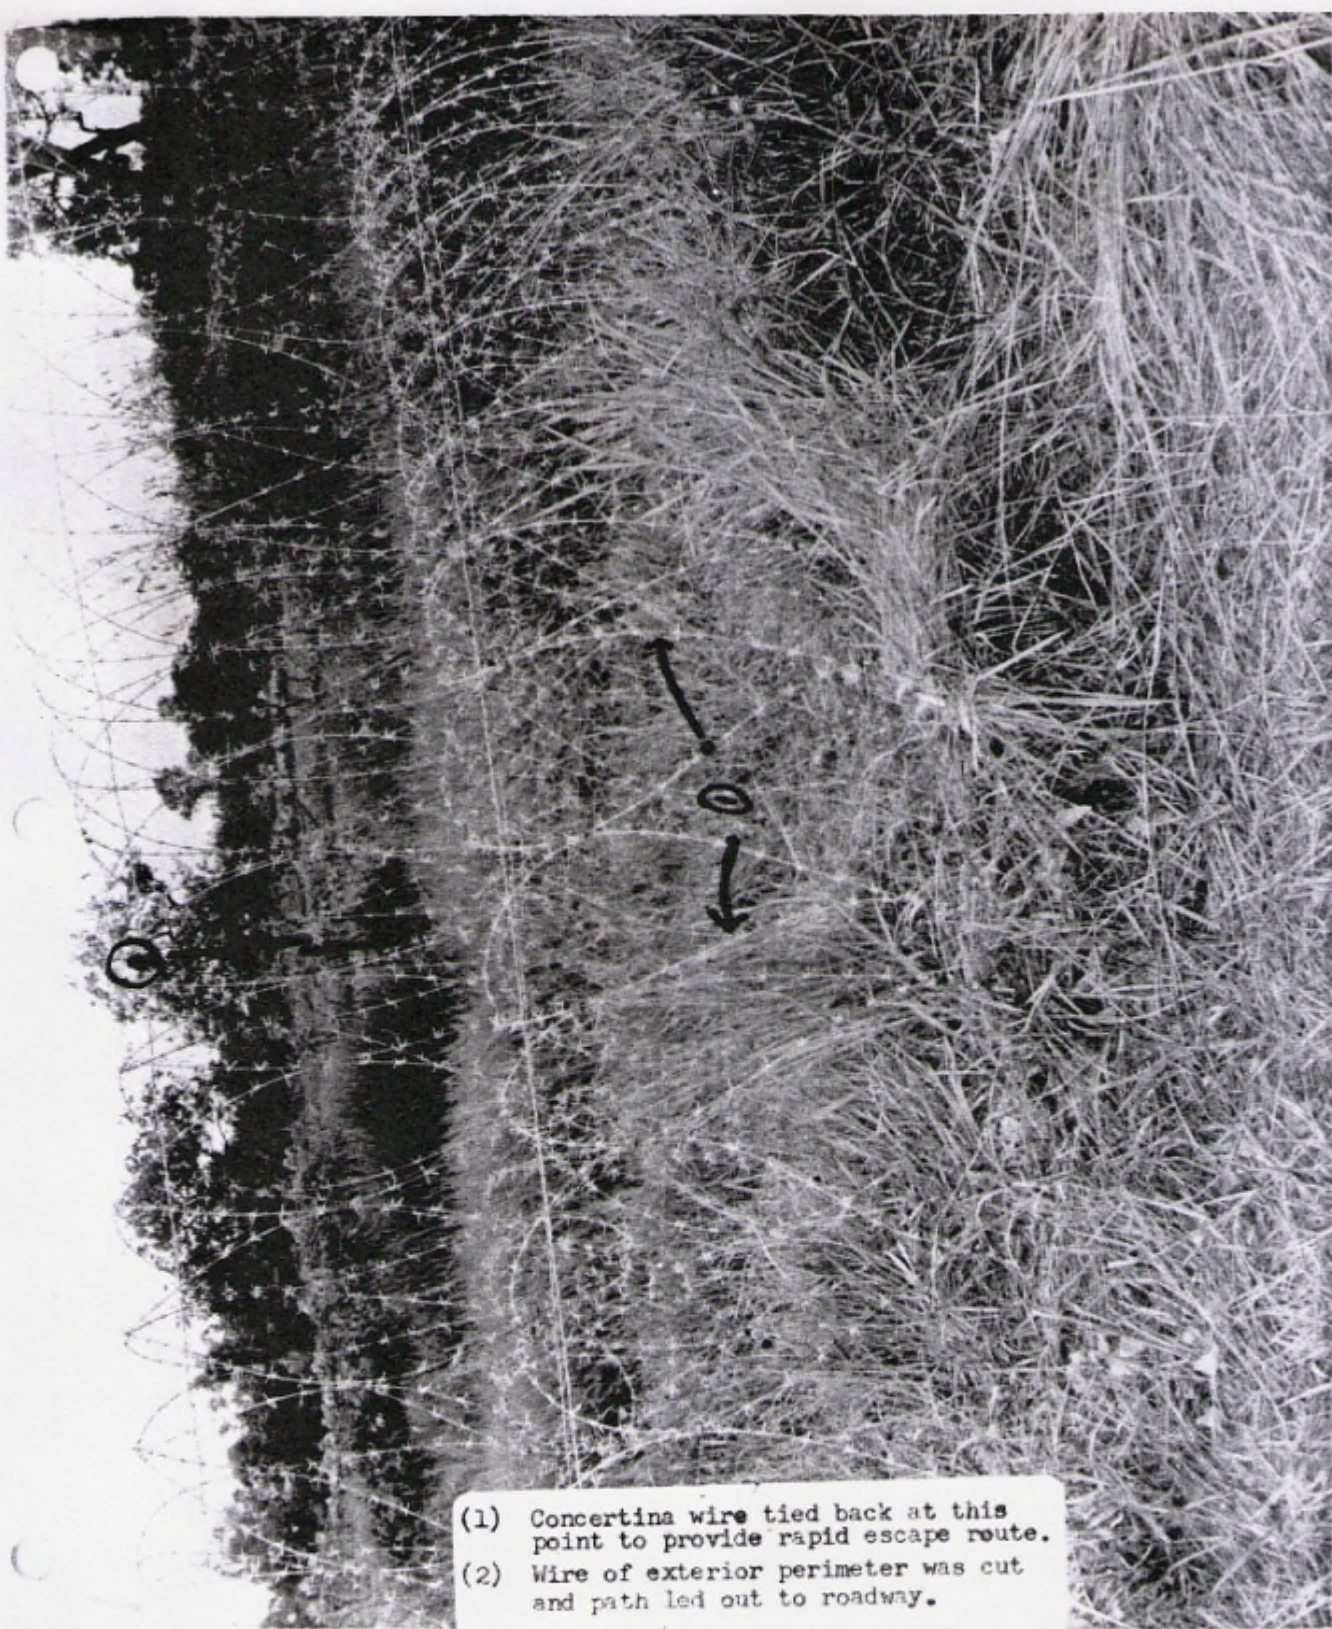
ATCNS

3. (C) A piece of fatigue type material had been used to tie the concertina wire back to provide an opening. Only the inside strands of the wire were tied.

- (1) Concertina wire tied back at this point to provide rapid escape route.
- (2) Wire of exterior perimeter was cut and path led out to roadway.

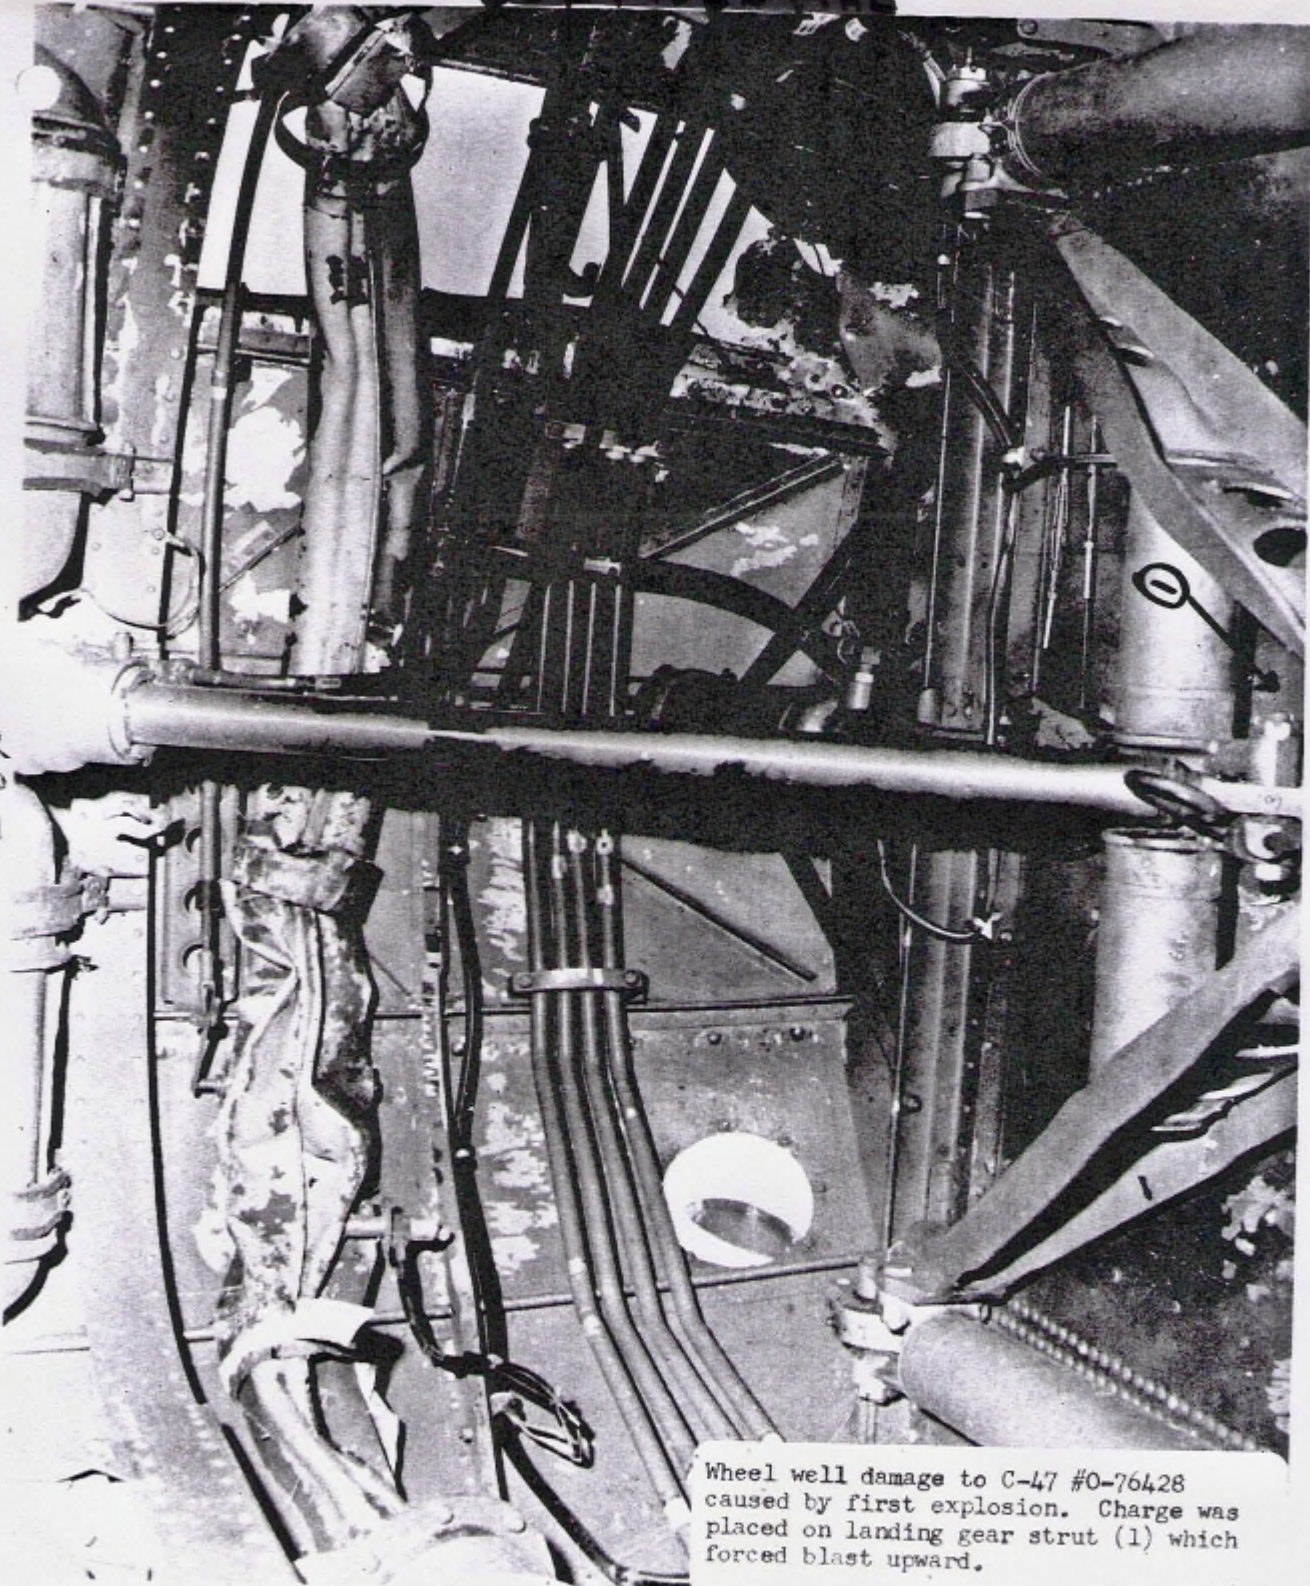
ATLH 6

a. (C) The 0200 explosion occurred at C-47 #0-76428, parked approximately midway of the C-47 parking apron.

c. (C) The 0209 explosion detonated in the vicinity of C-47 #0-75202, parked adjacent to and East of the first C-47 affected by the 0200 explosion. Subsequently, it was determined that both explosions at the C-47 parking apron had detonated in the left wheel well of the two C-47s. Damage was first evaluated as minor due to the affected area being confined to the wheel well (s) area. Later it was established that damage had been found to extend throughout the left wing(s).

1. (C) C-47, serial number 0-70428 (cargo) damage left wheel well, left wing, left landing gear strut and left tire. No cover provided for these aircraft.

Wheel well damage to C-47 #O-76428 caused by first explosion. Charge was placed on landing gear strut (1) which forced blast upward.

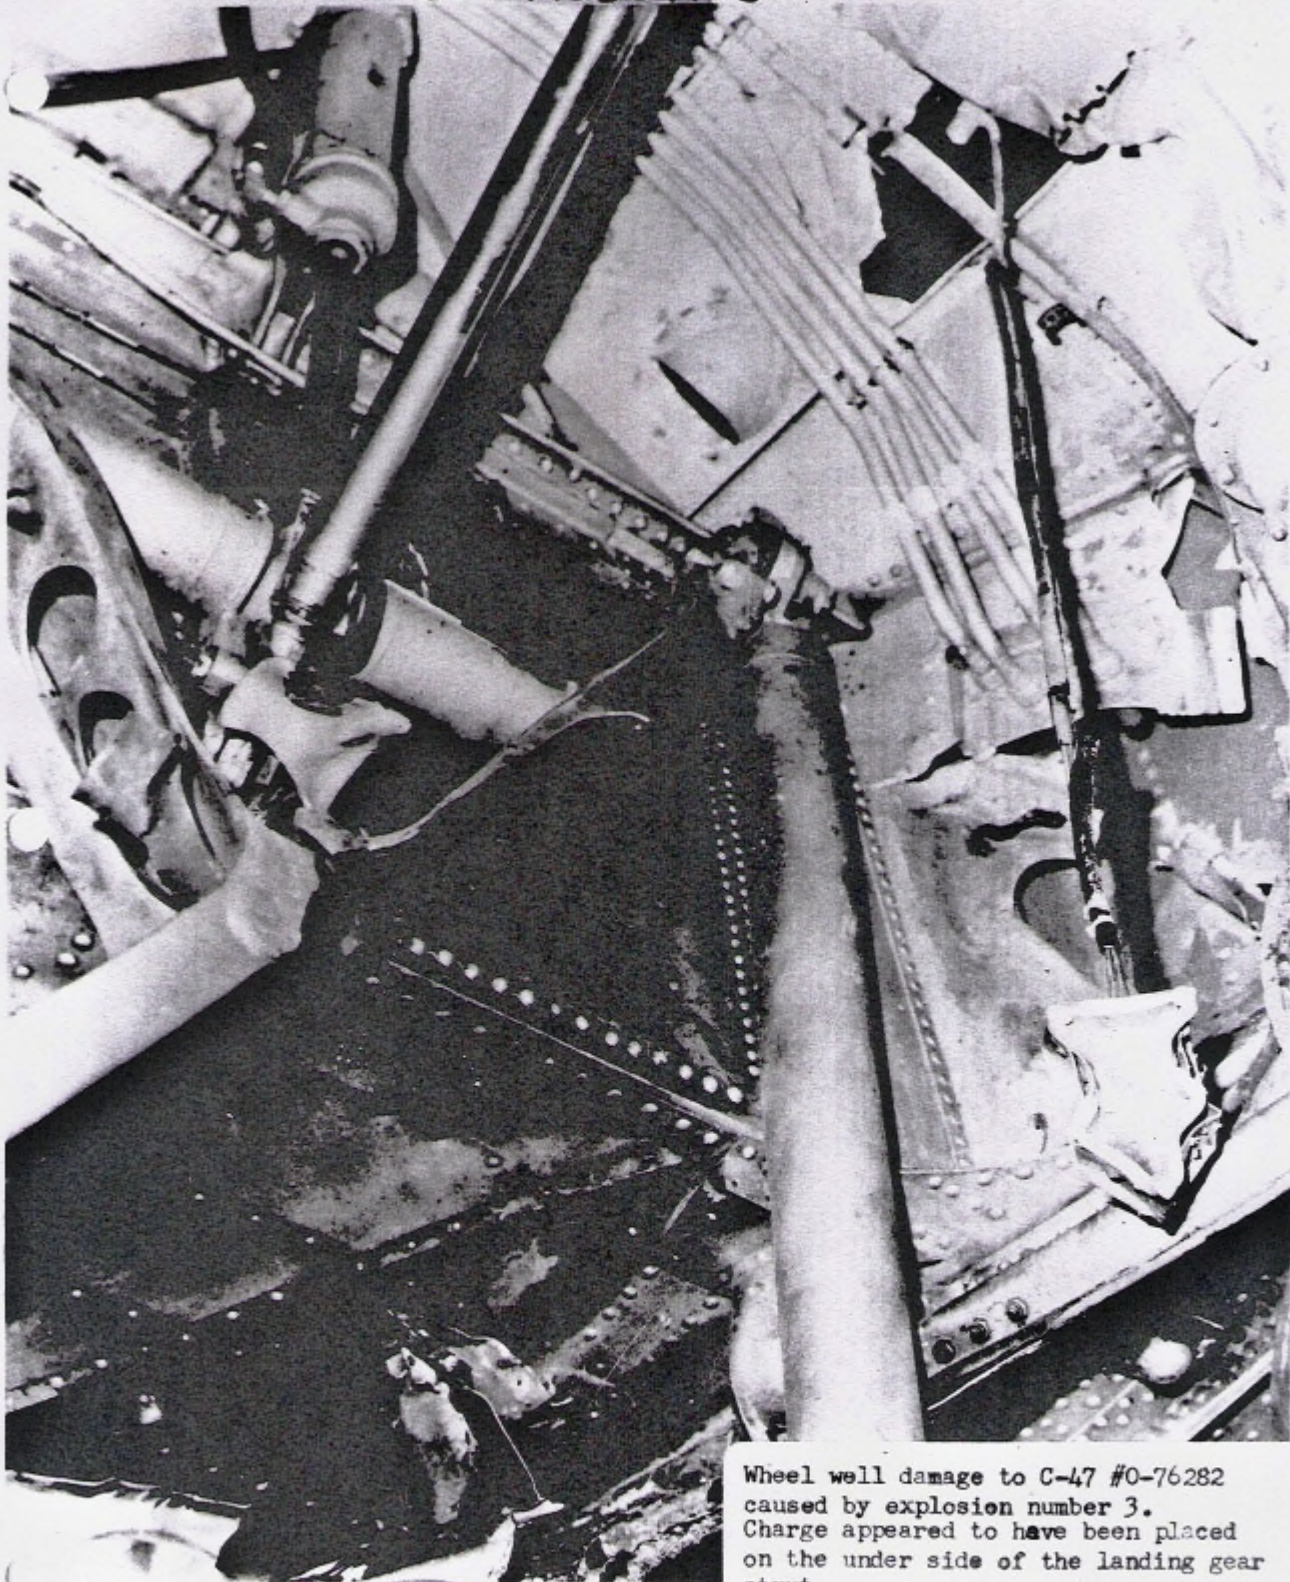
ATCH 7

2. (C) C-47, serial number G-0202 (cargo), damage to left wheel well and left wing.

Wheel well damage to C-47 #0-76282
caused by explosion number 3.
Charge appeared to have been placed
on the under side of the landing gear
strut.

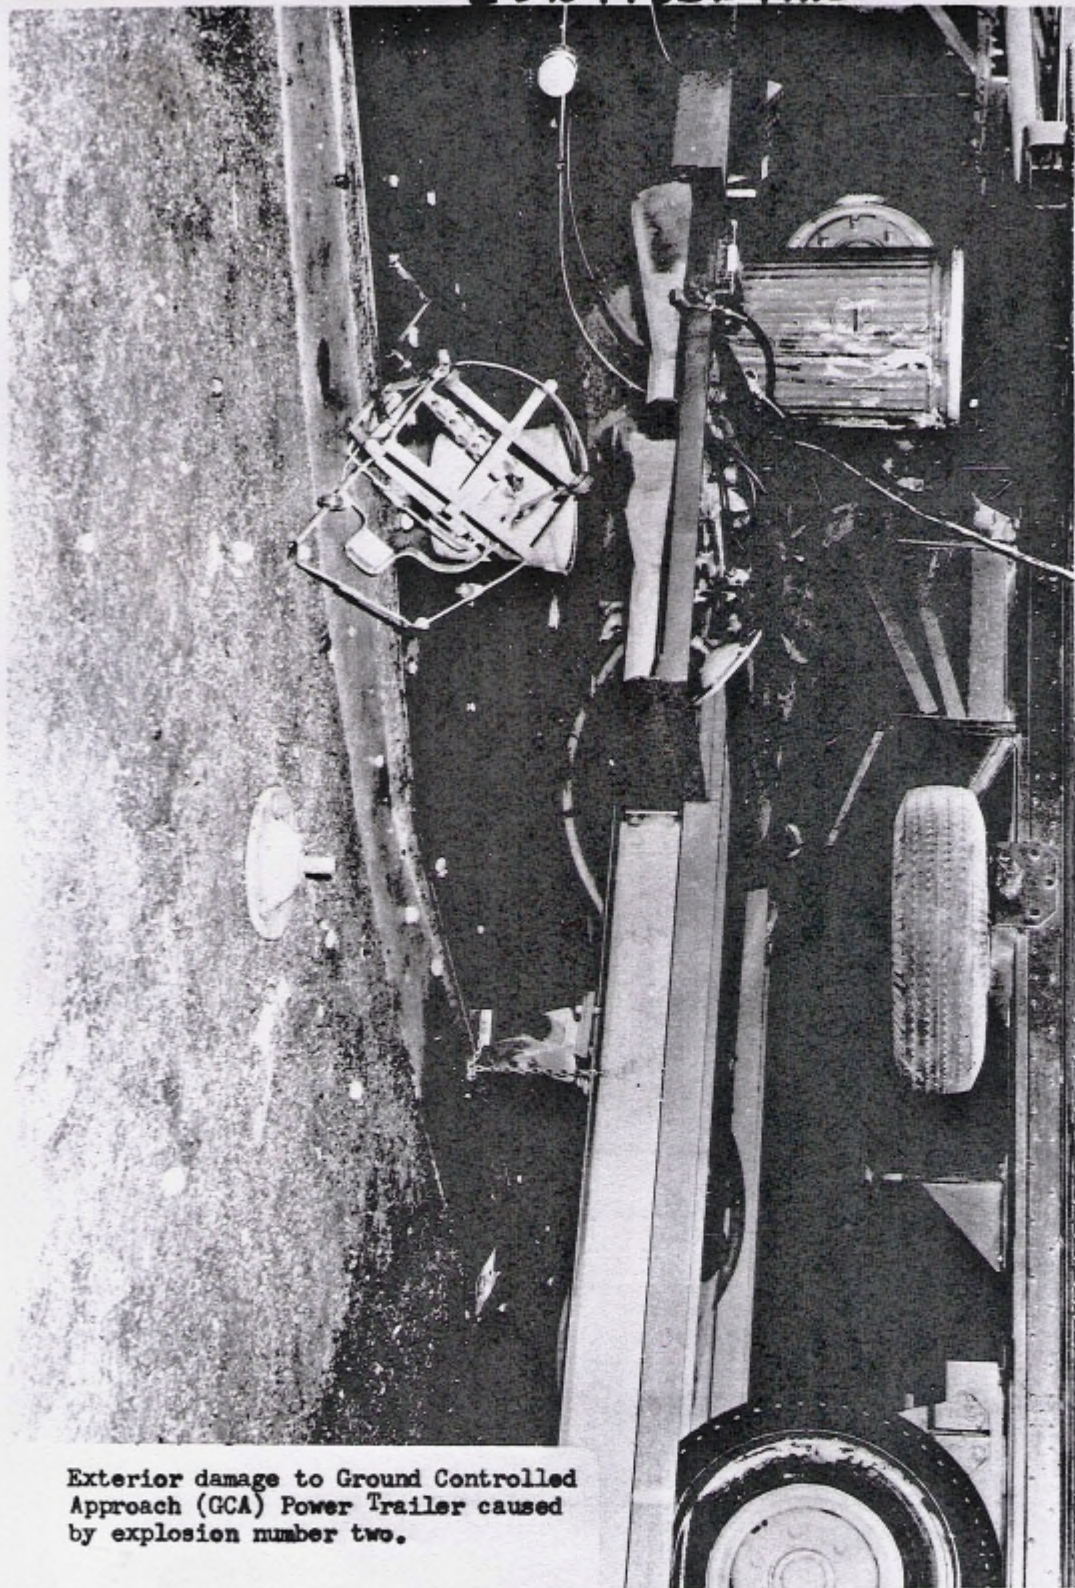
ATCH 8

b. (C) The 0205 explosion occurred on the East side of the GCA Power unit. Subsequent inspection revealed that the explosion detonated underneath the power unit trailer and had apparently been placed on the frame structure by the perpetrator. The explosion damaged the frame structure, floor and did minor damage to internal power equipment. The unit had resumed operation by 0530 hours.

Exterior damage to Ground Controlled Approach (GCA) Power Trailer caused by explosion number two.

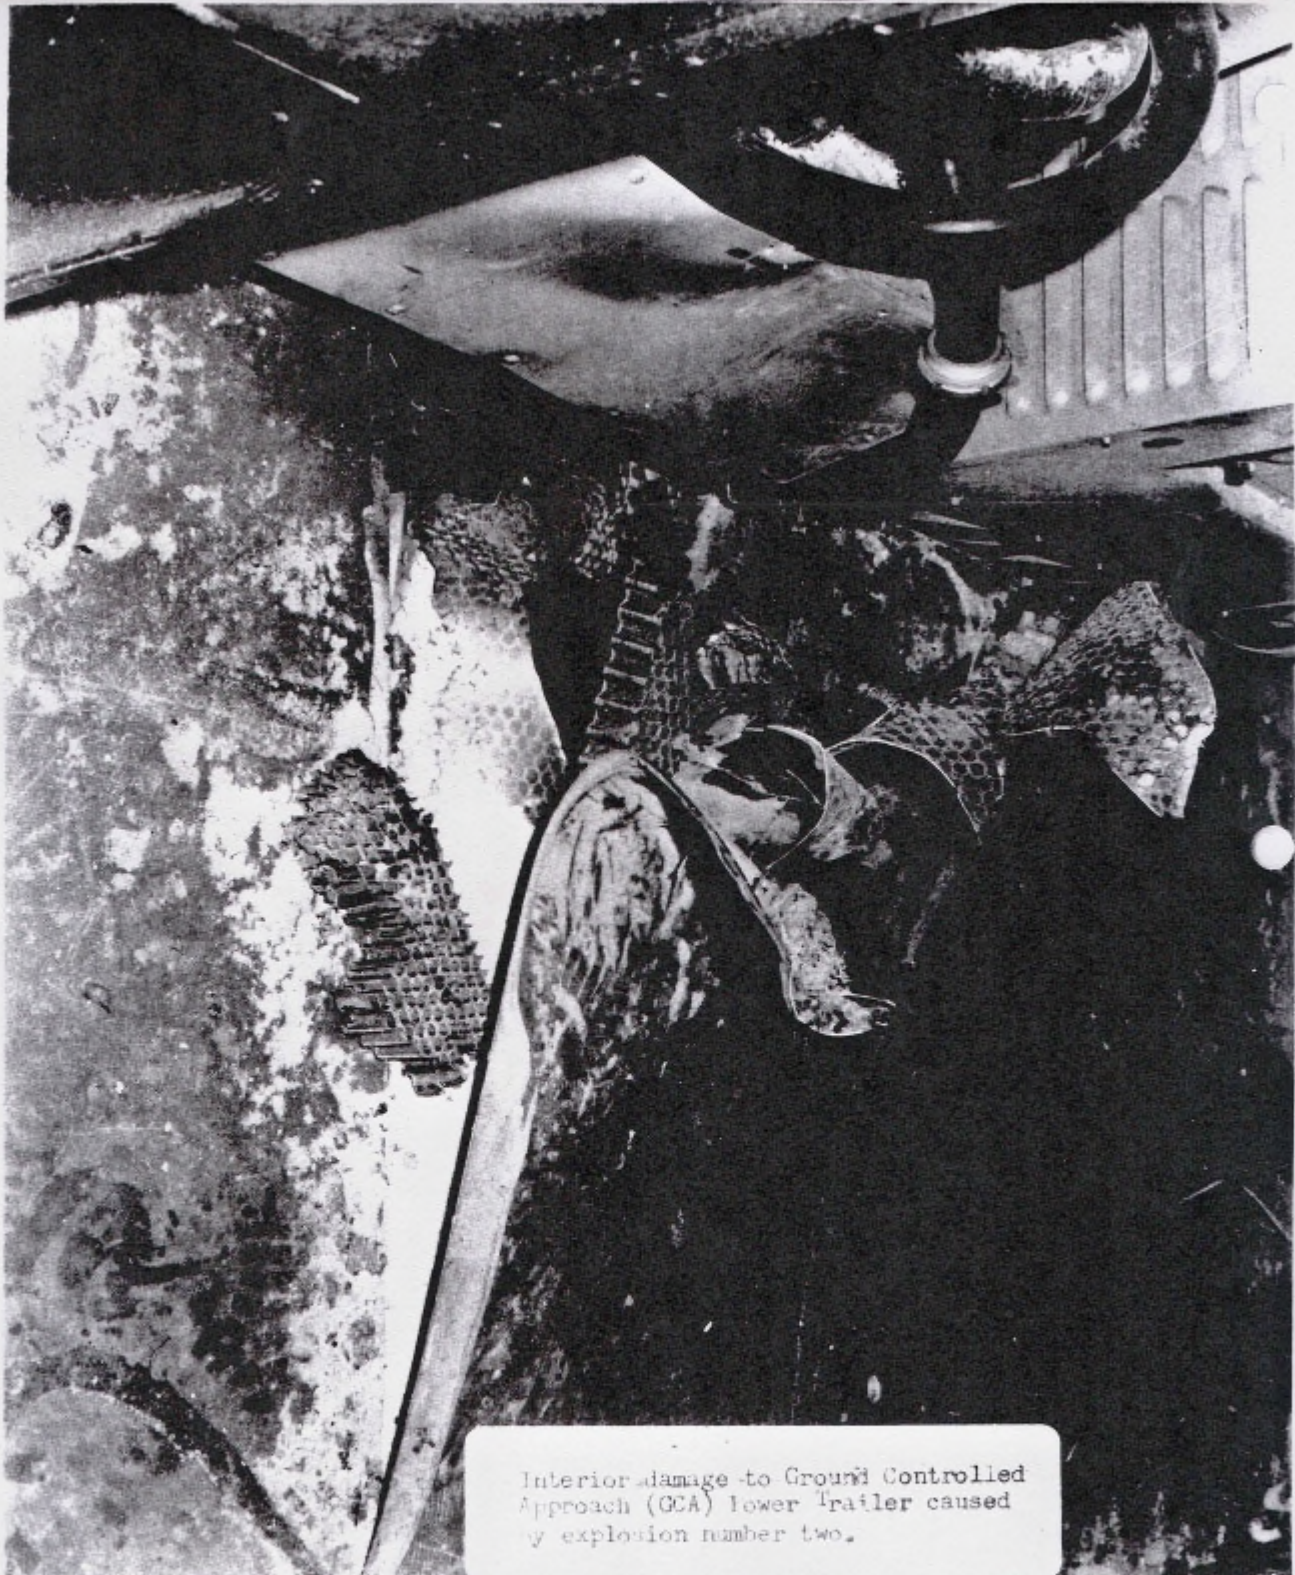
ATCA 7

Interior damage to Ground Controlled Approach (GCA) lower Trailer caused by explosion number two.

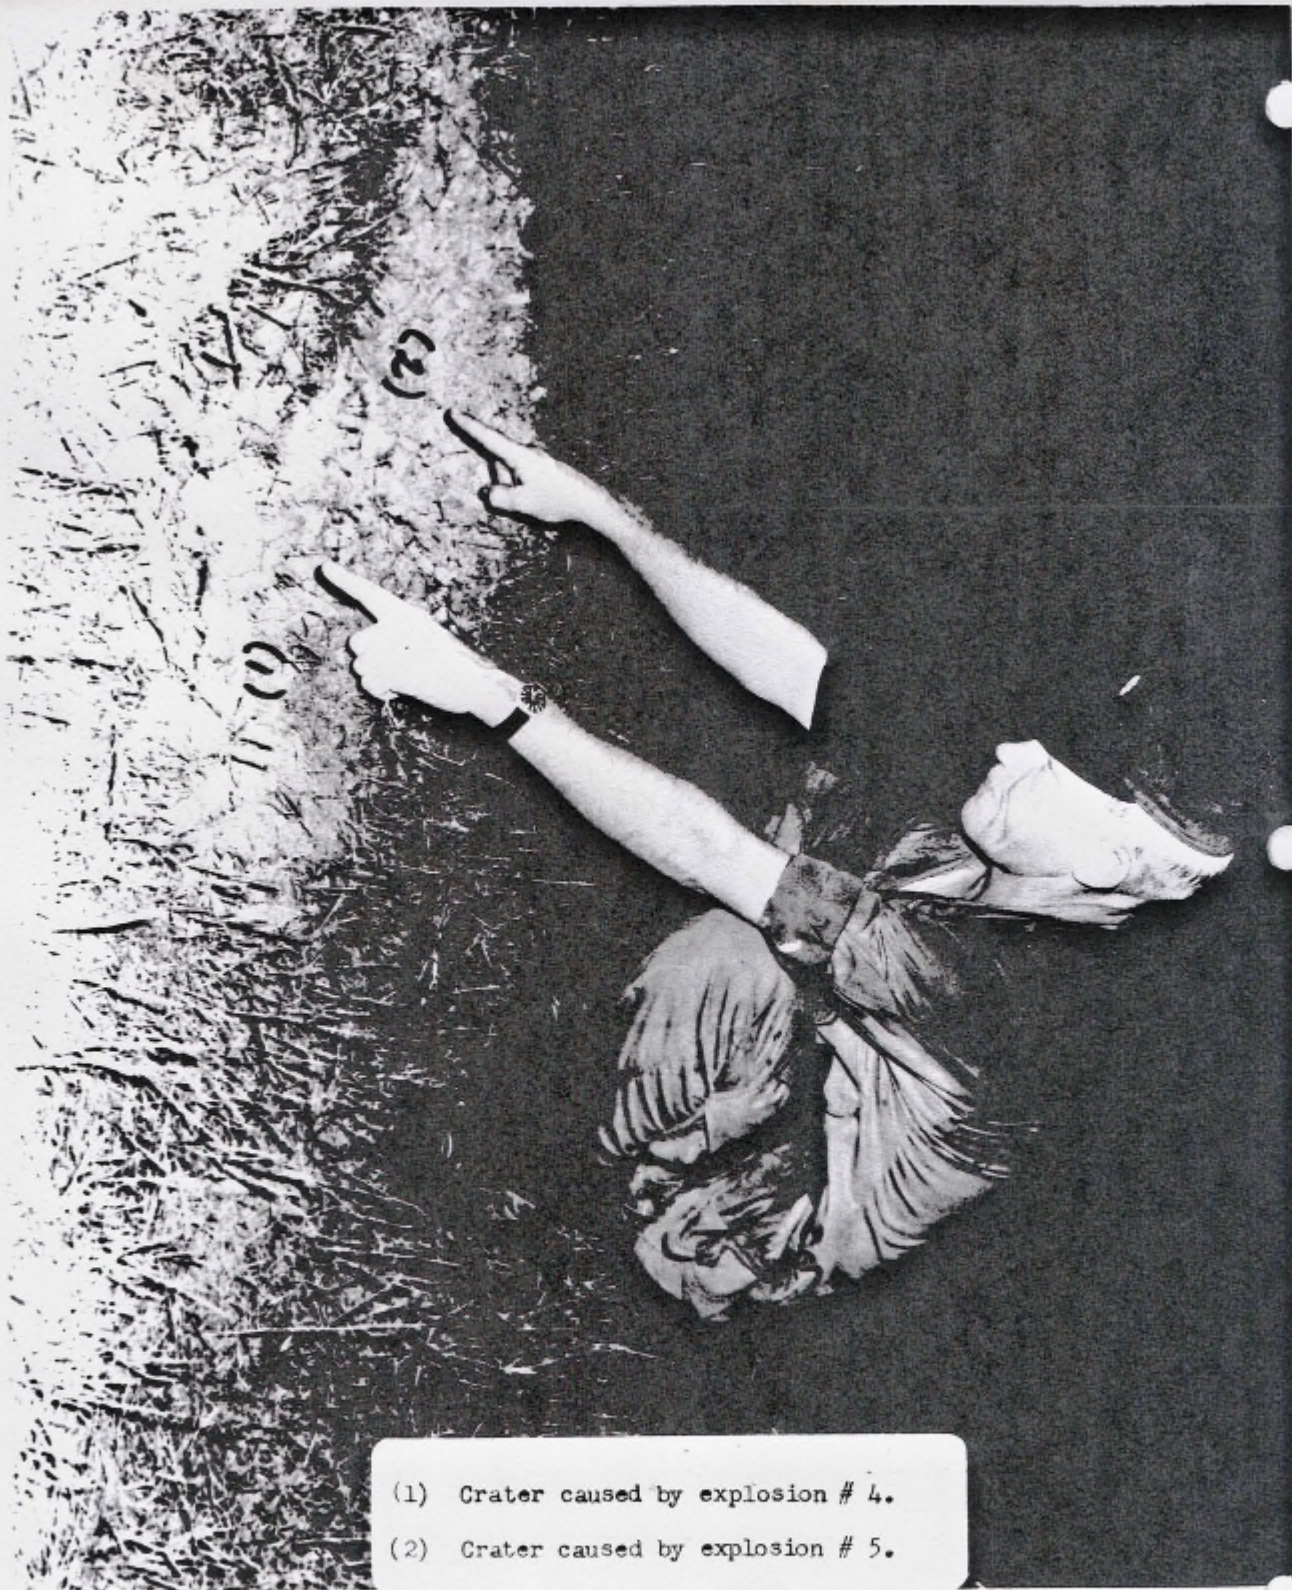
ATCH 1

d. (C) The 0222 and 0224 explosions had detonated approximately 10 meters Southwest of the 5000 foot marker of the major runway. Two small craters were later discovered. No damage occurred as a result of these two explosions.

- (1) Crater caused by explosion # 4.
- (2) Crater caused by explosion # 5.

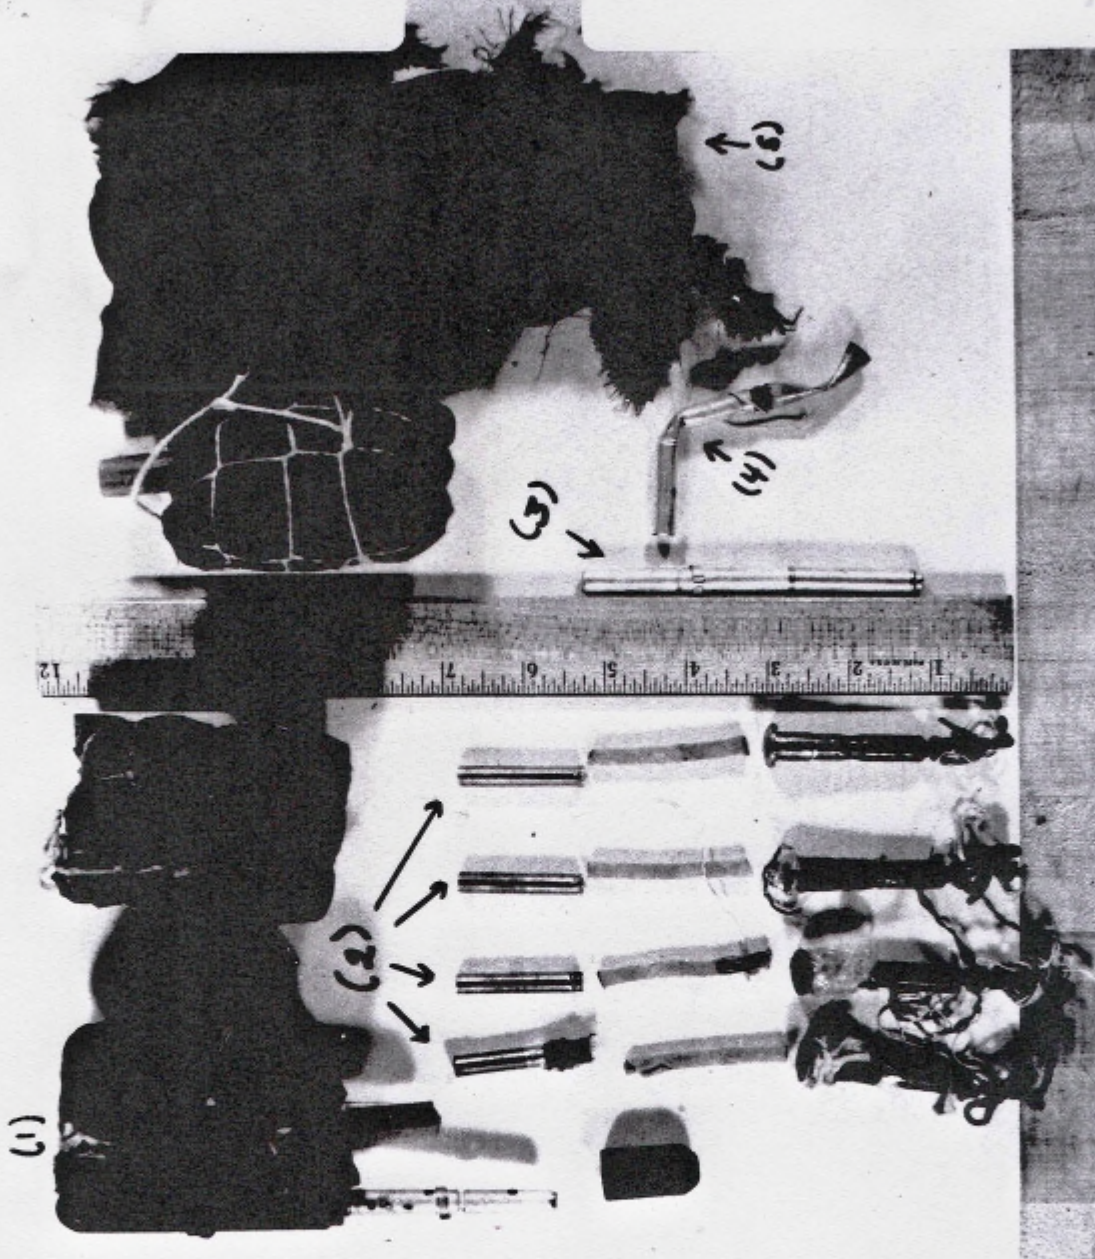
ATCH 12

(d) (C) One charge was found on the southeast side of the active runway. This charge appeared to have been near explosion four and five on the north side of the runway and could possibly have been blown across the runway. The chemical pencil detonator was cent just below the chemical container and the firing mechanism was unable to function. (This determination was made by SOV personnel).

(5) Cap for plastic container used to store chemical fuse/detonator was not in use.

... charge, complete with chem-
... fuse/detonator and wooden plug.
... labeled friction fuse/detonator.
... fuse/detonator.

(4) Damaged chemical fuse/detonator found with undetonated charge believed to have been set to detonate with #4 and #5. Blown across active runway.

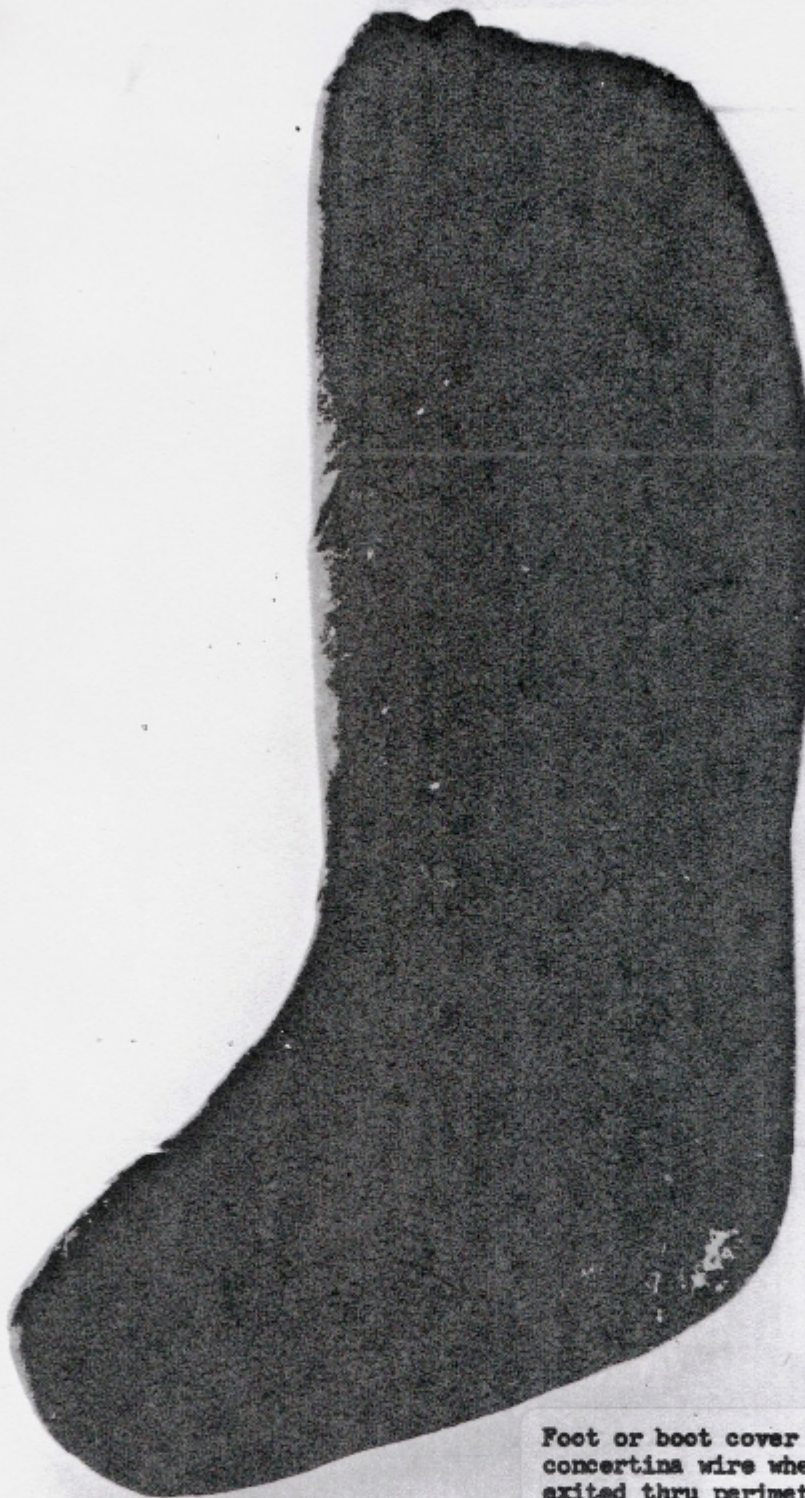
ATCH 13

Foot or boot cover discovered caught in concertina wire where infiltrators exited thru perimeter fence.

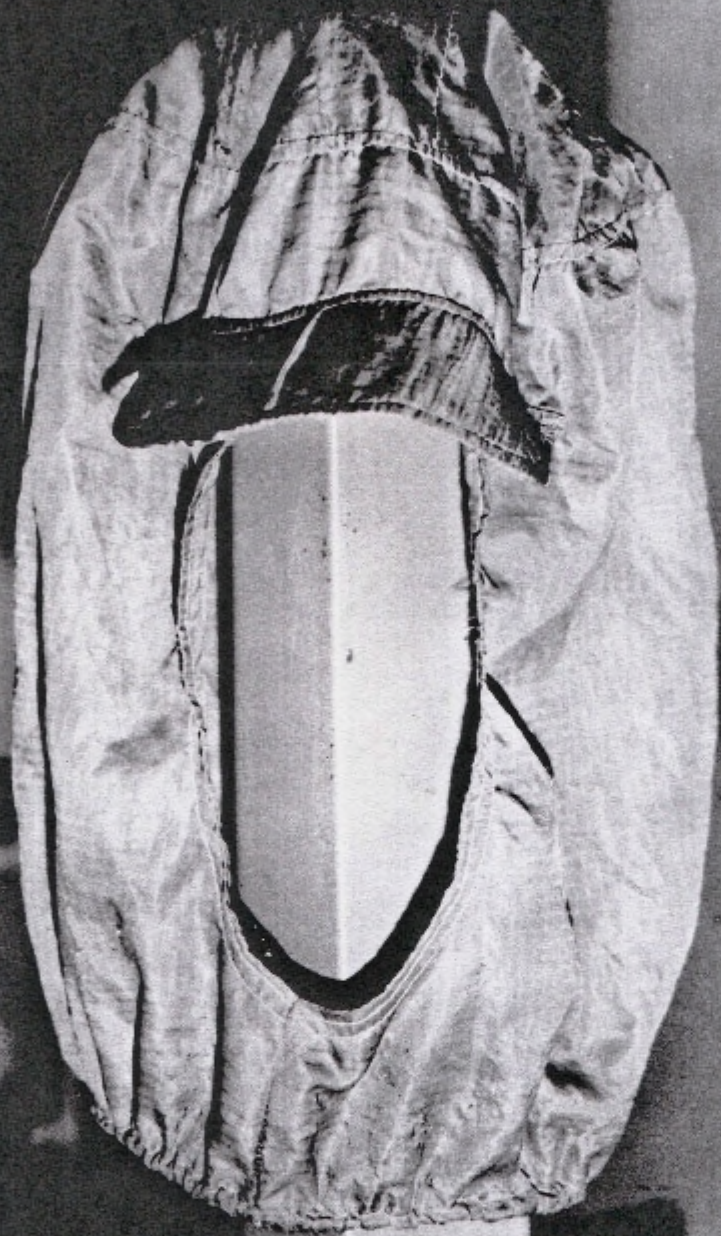
ATCH 14

Hood discovered by Provincial Police during search outside perimeter. The only item released by Police for photographing.

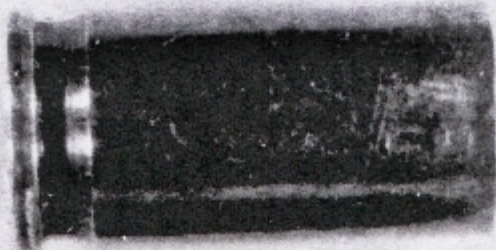
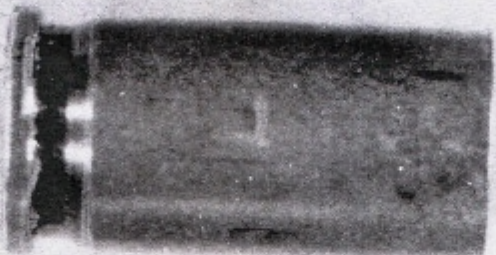
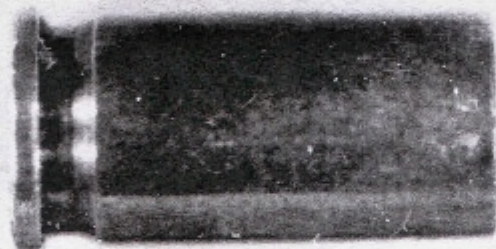
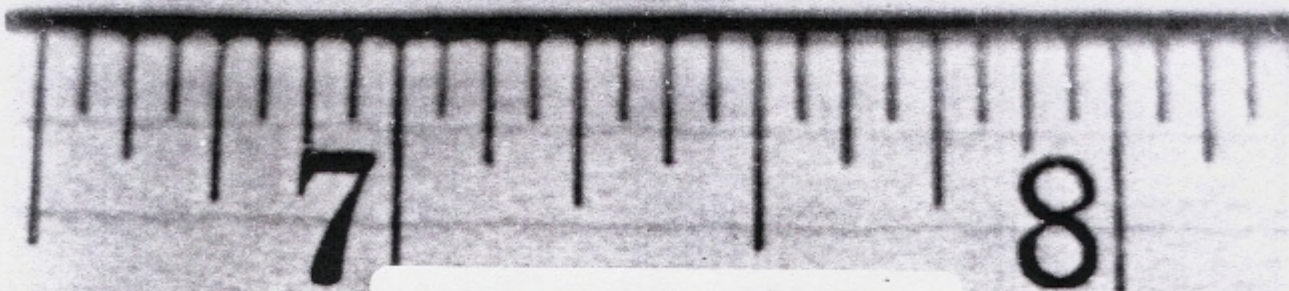
ATCH 1.

Three shell casings discovered with
aid of metal detector. CAL 7.65

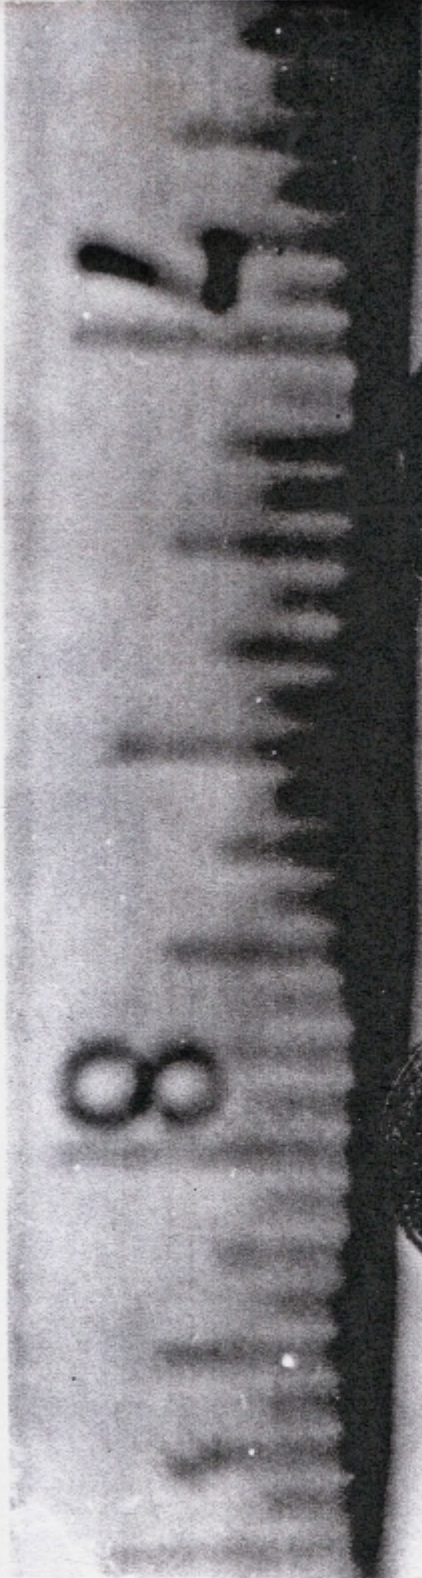
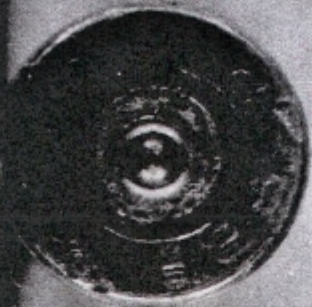
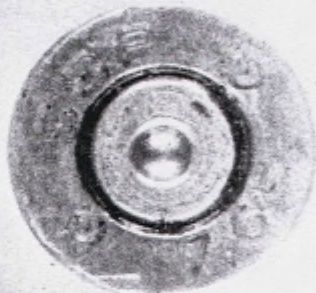
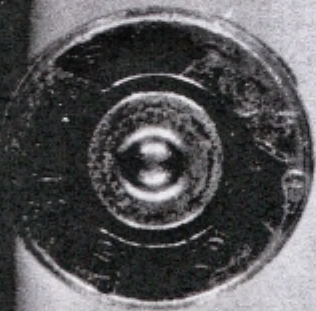
ATCH 2 (

View of shell casings depicting markings and calibre.
